INDUSTRIAL FIELD REPORT

OFFSHORE OIL RIG - LEAKING CIP TANK

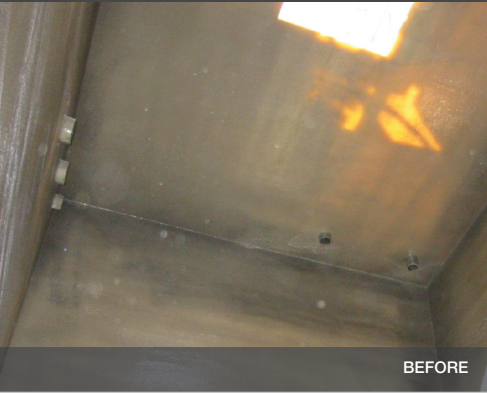
BEFORE

On the oil rig **SOUTH ARNE** in the Danish North sea, they were experiencing a constant loss of fluids in their CIP Tank (clean in place tank). The fiberglass tank didn't have the right structural support, resulting in cracks in the joints of walls and floor.
