LIGHT INDUSTRIAL CASE STUDY

DELIVERY TRUCK BUMPERS

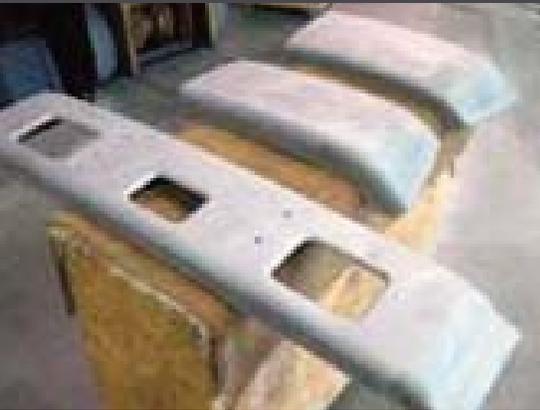
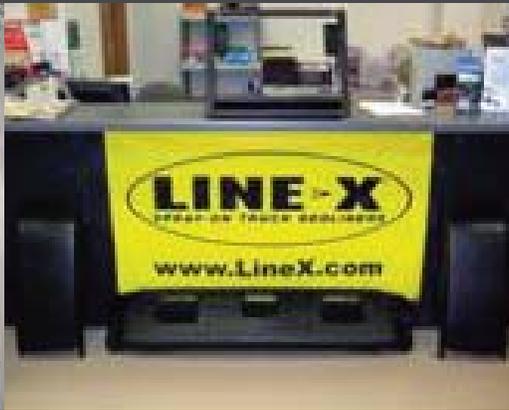
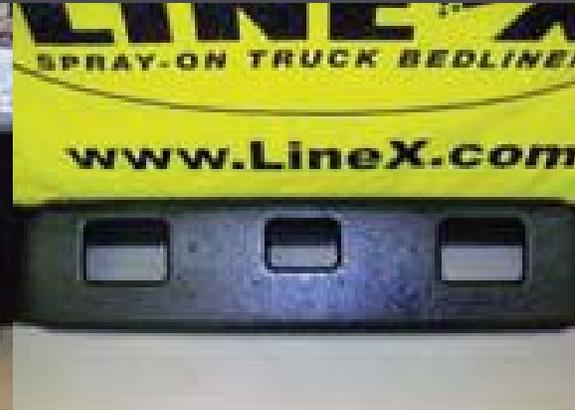
Bumpers on the delivery trucks of an lowa-based beer distributor were being corroded during normal driving conditions. Rocks and debris easily chipped the thin paint exposing the steel underneath. Salt, tar and other harsh road chemicals were then able to corrode the metal bumper, compromising its integrity and appearance. This situation forced the beer distributor to repaint the bumpers every year.

The bumpers were removed from each delivery truck in three pieces. One bumper set was completed at a time. Each piece was white blasted prior to the client delivering the project. The metal was primed with SF-515 and sprayed the same day. LINE-X® material was sprayed approximately 70 mils thick on the front and the back of each piece to achieve appropriate levels of impact and abrasion resistance. LINE-X XTRA® was applied in black, providing superior gloss retention and UV stability to accommodate the client's aesthetic requirements.

The delivery truck bumpers were coated with LINE-X XS-100 and LINE-X XTRA. Application was completed in eight hours.
