LIGHT INDUSTRIAL CASE STUDY

OIL PANS

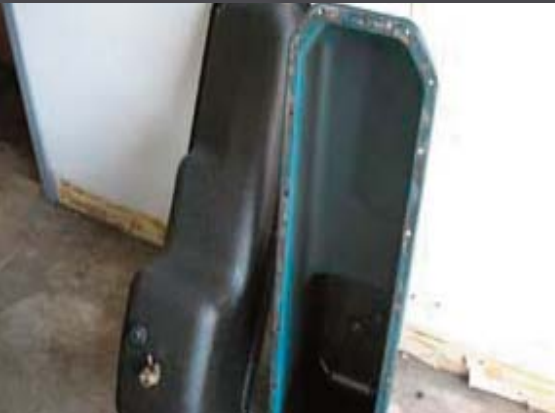
School buses, county and state service vehicles and public utility vehicles all have oil pans that are susceptible to serious damage during routine driving condition. Rocks and road debris often ding or dent the pans. They can also scratch the thin paint exposing the bare steel underneath to corrosion, rust and eventually leakage. The road debris can even puncture the oil tank, especially after repeated impacts. The risk is compounded when the vehicle travels on gravel or dirt roads or on rural routes.

LINE-X XS-100 was applied in standard black on the outside of the pans to provide sustainable impact resistance. The application was completed with limited interruption in daily activities.
