Vault Toilet

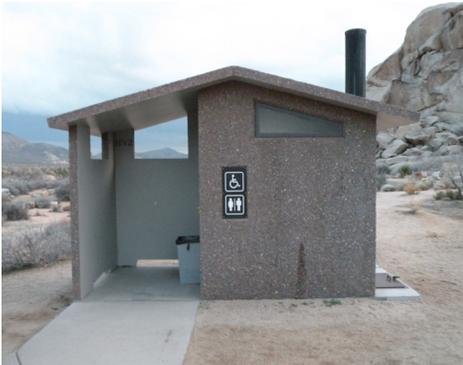
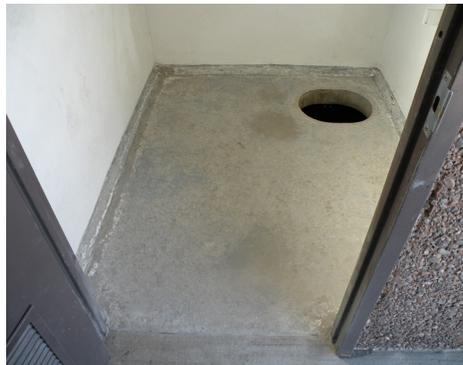
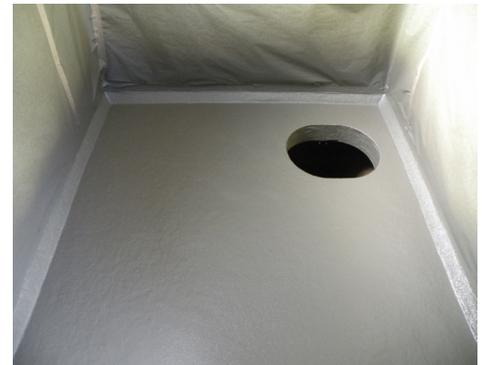
Vault toilet systems in National Parks are severely abused by outdoor elements. The vault toilets in Joshua Tree National Park in California were particularly susceptible to damage caused by extreme temperatures, UV exposure and sand storms. They are also put to the test by the campers who set fires on the floors and defaced the walls and ceiling.

The park/campground staff are responsible for keeping the facilities clean and aesthetically appealing for the public. Some of the vaults that have fire or other damage need to be repainted on a daily basis. This becomes very costly in materials and labor for the National Park service.

To apply the LINE-X coating, the concrete vault floor was stripped of the existing epoxy coating and sanded to achieve the proper etch profile. The walls and ceiling were tested to verify proper adhesion and prepped for spraying.

A dark grey pigment was chosen for the floor and applied to a thickness of 80 mils. A fire-rated topcoat was added for additional surface protection.

The application process took approximately 8 hours. The vault was back in full operation within 24 hours of completion.
