INDUSTRIAL FIELD REPORT

OFFSHORE OIL RIG - LEAKING CIP TANK

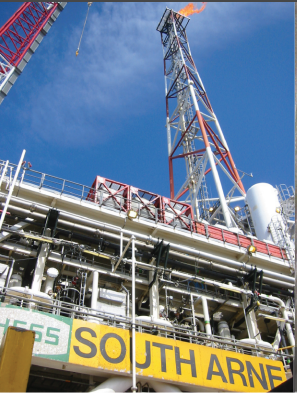
BEFORE

On the oil rig **SOUTH ARNE** in the Danish North sea, they were experiencing a constant loss of fluids in their CIP Tank (clean in place tank). The fiberglass tank didn't have the right structural support, resulting in cracks in the joints of walls and floor.

LINE-X® XS350 was sprayed 2.5 mm (1/8 inch) thick onto the fiberglass with tenacious adhesion.

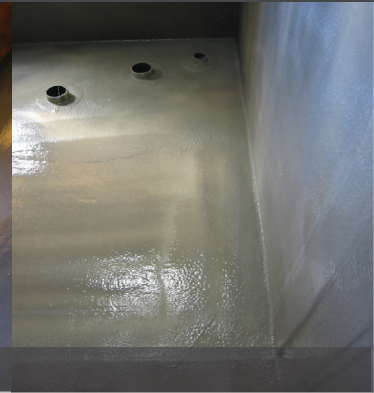
AFTER

The coating of LINE-X was completed in 2 hours and back in service soon after with no change in daily operations.
