LIGHT INDUSTRIAL CASE STUDY

SHOWER STALLS

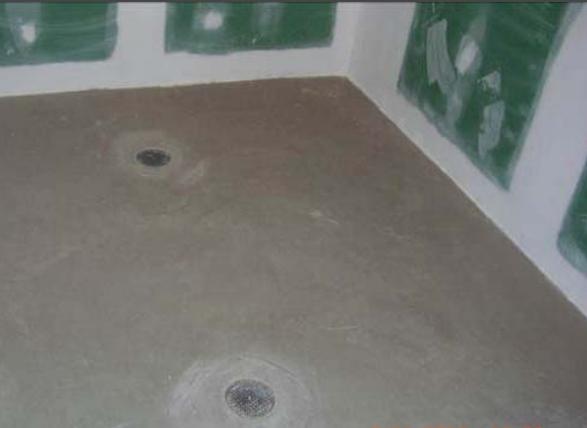
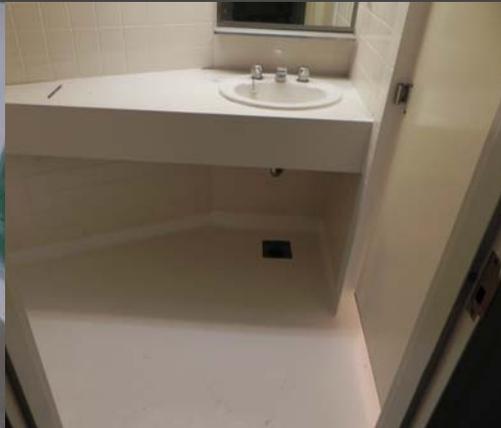
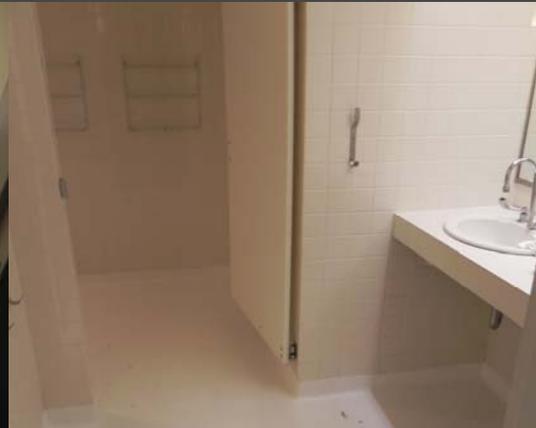
- The showers were tiled, a slip hazard in this wet environment
- The grout was unsanitary, holding onto moisture and creating an environment where mold, bacteria and other germs could grow
- The tile was easily damaged from hospital equipment. Once damaged, moisture seeped behind the tile causing the drywall to deteriorate allowing mold and bacteria to grow in the wall

The floor, walls and ceiling of the shower stalls were coated in white LINE-X XS-350 and topcoated with white LINE-X ASPART-X.

Each stall was completed by two applicators in about 4-6 hours saving the hospital significant downtime over an epoxy coating they were using. The stalls ranged from about 80-300 square feet, including the floor, walls and ceiling.
